## 220 kV 电缆线路终端故障及仿真分析

**摘要:**为分析某 220 kV 电缆线路终端应力锥、电缆表面贴合状态与故障发生的深层次原因, 本文对某 220 kV 故障电缆终端开展故障解体、X 射线检测以及仿真工作, 分析发现接头应力锥过盈量高于安装工艺要求, 且搭接面表面不平整。在应力锥、电缆表面贴合良好时, 运行电压下应力锥、电缆主绝缘最大电场强度均远小于对应绝缘材料的击穿场强, 而应力锥、电缆表面贴合不良交界面存在微小气隙时, 运行电压下气隙内部电场强度大于空气击穿场强, 表明运行电压下气隙内部存在放电现象。因此, 电缆终端应力锥、电缆表面贴合不良、交界面存在微小气隙时, 在运行电压下, 气隙内长期放电引起主绝缘破坏是造成电缆故障的原因。

## Terminal Fault and Simulation Analysis of 220 kV Cable Line

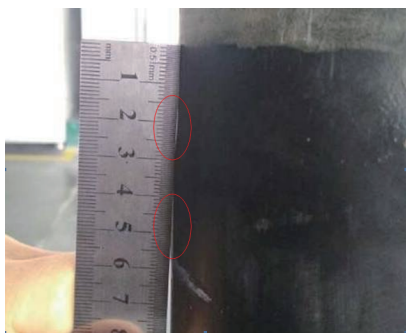
图1 终端击穿故障解体检测

- (1) 终端接头封铅脱离, 尾管炸裂;
- (2) 三元乙丙橡胶预制件部分遗失, 部分铜网剥离缺失;
- (3) 在应力锥内部半导体零位线上 2 cm 绝缘处发生击穿;
- (4) 在应力锥内部击穿点上部出现裂痕, 电缆绝缘表面碳化严重, 并且出现烧痕;
- (5) 击穿点部位绝缘外半导体层外翻, 并且在击穿点背侧应力锥底部位置距离外半导体层末端 55 mm;
- (6) 应力锥半导体层末端往下 20 mm 和 50 mm 处半导体层过渡段倾斜(见图 1)。

对现场电力电缆附件绝缘材料和应力锥材料进行性能分析,其均满足相应的电缆标准。由图1可知,电缆外半导体层存在打磨不平现象,过渡不平滑。此外,根据电缆附件厂家提供的终端安装记录,电缆外半导体层外径测量值 114.9 mm,应力锥内径测量值为 106 mm,过盈量 8.9 mm,高于安装工艺要求 11.2%(安装工艺为 4~8 mm)。由此可见,电缆附件安装过程存在一定施工缺陷。

建议加强电缆终端制作单位工艺技术水平,切实提高电缆附件现场制作质量;加强电缆终端制作现场技术监督工作,仔细核查应力锥尺寸过盈量、电缆外半导体层过渡平整性等关键技术参数;针对同批次在运电缆终端进行排查,重点筛查应力锥过盈量等技术参数;对发现的应力锥过盈量严重超标的电缆终端,采用电缆局放重症监护等装备进行局部放电情况实时监测,发现局放量有增大趋势时,应及时进行更换。

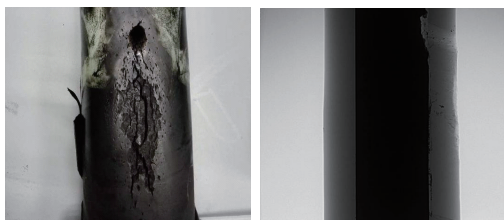
(a) 绝缘击穿通道沿轴向倾斜

- (1) 电缆绝缘击穿通道,沿下部轴向方向倾斜(见图2a),沟壑碳化区域未发现与线芯贯穿通道;
- (2) 电缆撕裂面内部贯穿到铜芯,撕裂处与击穿点沿铜芯贯通(见图2b)。

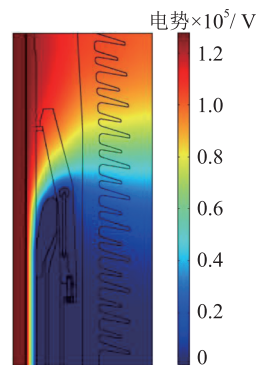
图4 220 kV 瓷套终端电势分布

此时,电缆终端应力锥与电缆紧密贴合,电缆终端电势如图4所示,电缆终端电势等位线如图5所示。从图中可以发现其等位线均匀分布,未发现明显电场畸变点。

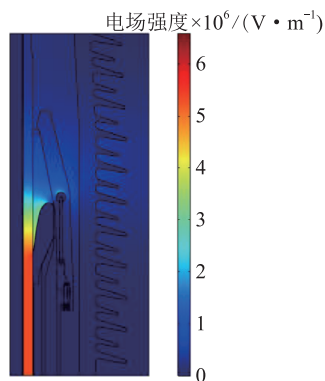
图6 220 kV 瓷套终端电场强度分布

图6为220 kV瓷套终端电场强度示意图,从仿真结果可以发现,电场强度最大点位于电缆本体主

Fig.5 Equipotential line distribution of 220 kV terminal 绝缘中,值为  $6.6 \text{ kV/mm}$ ,小于 GB/T 18890.2—2015 中规定的交联聚乙烯击穿场强  $30 \text{ kV/mm}$ <sup>[17]</sup>。应力锥绝缘中电场最大值为  $4.6 \text{ kV/mm}$ ,小于长缆附件提供的三元乙丙橡胶材料的击穿场强  $35 \text{ kV/mm}$ 。

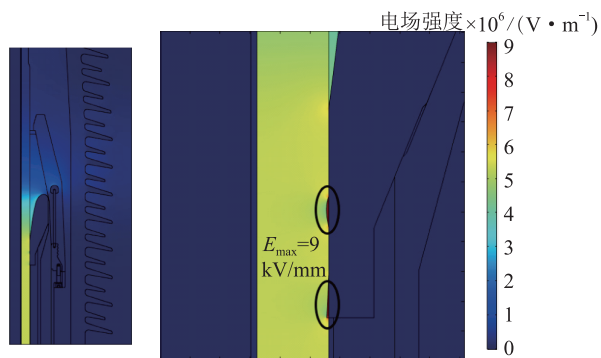
图7 220 kV 瓷套终端电场强度分布

若电缆终端应力锥与电缆贴合不良,则会在电缆绝缘与应力锥绝缘交界面存在微小气隙。此时电场强度如图7所示,在气隙处电场强度最大,为  $9 \text{ kV/mm}$ ,大于空气击穿场强会导致局部放电出现。

处打磨不平,电缆附件应力锥过盈量超过技术文件要求。当电缆半导体过渡处打磨不平时,会导致电缆绝缘与应力锥绝缘交界面存在微小气隙,在  $220 \text{ kV}$  线路运行电压作用下会引起局部放电从而引起绝缘劣化,从而导致绝缘材料内部电树枝老化或者击穿现象发生<sup>[18-20]</sup>;当电缆附件应力锥过盈量超标时,会导致应力锥在预扩张过程中形成机械损伤而导致电气性能下降。仿真发现,在应力锥、电缆表面贴合良好时,运行电压下应力锥、电缆主绝缘最大电场强度分别为  $4.6 \text{ kV/mm}$ 、 $6.6 \text{ kV/mm}$ ,均远小于对应绝缘材料的击穿场强,而应力锥、电缆表面贴合不良交界面存在微小气隙时,运行电压下气隙内部电场强度为  $9 \text{ kV/mm}$ ,大于空气  $3 \text{ kV/mm}$  的空气击穿场强,表明运行电压下气隙内部存在放电现象。
